Naust

– the boathouses of Nyköping and the echoes of power

Tomas Westberg

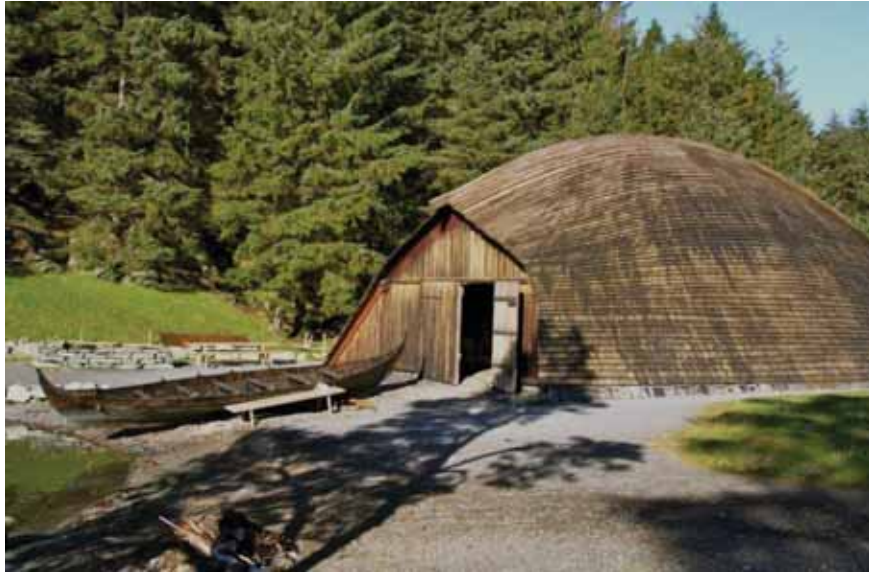
Figure 4. Reconstructed naust at Avaldsnes, Nordvegen Historiesenter. Used with permission.

As mentioned above, it is unlikely that the structures did not have closed surrounding walls (excepting the side facing the water). One possibility is that the roof was conjoined with the wall construction, following the angle and fastened to the supposed buttress-like/support post construction down towards the ground, albeit placing the drainage-trench on the outer side of the buildings (possibly similar to the reconstructed naust at Avaldsnes, fig. 4).
