# Trade and use of building lime

- early 19<sup>th</sup>-century lime barrels from an excavation in  
Uddevalla, Bohuslän

*Niklas Ytterberg & Kristin Balksten*

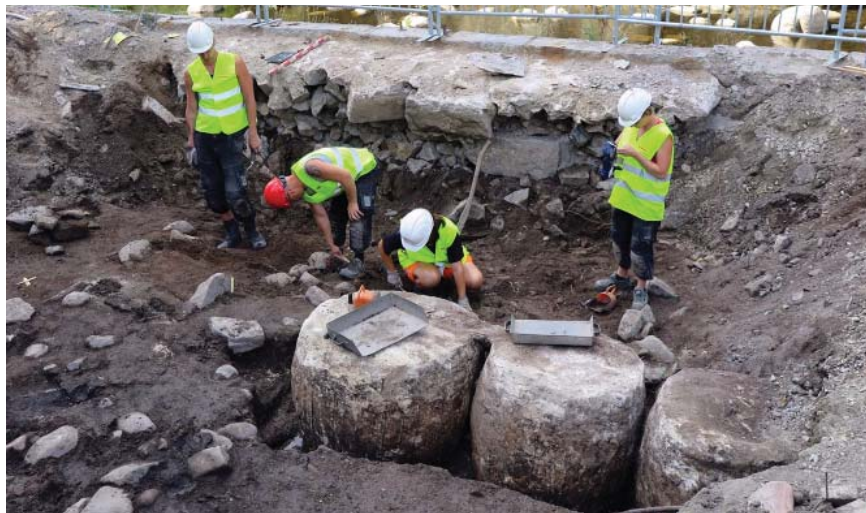
Figure 3a. Photo of the lime barrels (from the left) 4, 3 and 2, which were excavated during the summer of 2014. They have differing sizes but seem to hold similar lime putties. Photo: Kristin Balksten.

In order to gain a better understanding of how the lime putty was prepared and treated, a more detailed description of the barrels is required. The biggest barrel, to the north-west, measured 1.15 m in maximum width, and the second biggest, at the end of the row to the south-east, measured around 1 m. The two barrels in the middle were slightly smaller, c. 0.8 m. The height differed from c. 0.8 to 1 m, making the barrels a bit wider than they were high. The barrels were bulged slightly in the middle, as usual. The staves were very poorly preserved. Impressions of the staves in the lime putty revealed an individual width of 0.10 - 0.15 m (4 to 6 inches) and a thickness of about 25 mm (1 inch). Preserved fragments of hoops indicate that they appear to be made of birch, whereas the bases of the barrels are made of pine. No head or lids are preserved, but these may very well never have been present. Three of the barrels contained a more greyish, lumpy lime and one barrel a distinctly white, creamy lime. We saw quite a lot of lime lumps in the pit, especially in the top fill close to the barrels' mouths. A probable explanation for this is that quicklime spilled over in the process of tipping it from smaller barrels to these ground-fixed barrels.

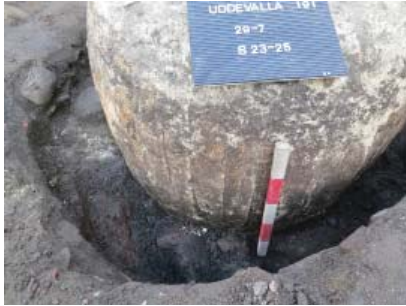
Figure 3b. Close-up of lime barrel 3 with the individual birch staves clearly visible. Photo: Niklas Ytterberg.

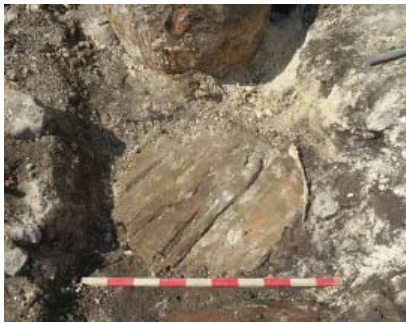
Figure 3c. Photo of the base of barrel 4, made of pine. Photo: Veronica Forsblom Ljungdahl.

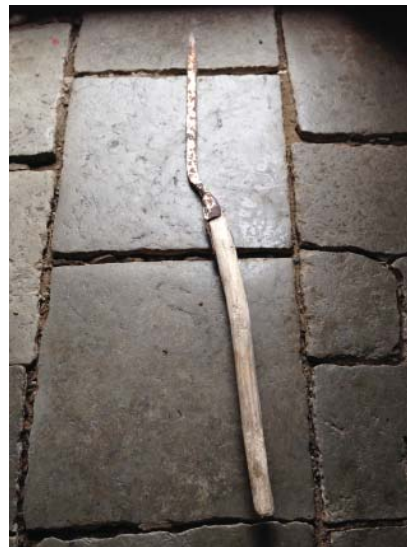
Figure 4. Lime whip from Svenneby old church. Photo: Kristin Balksten.

be recognized by the specific lime lumps in historic mortars (Balksten 2010). To be able to use earth slaked lime as a binder it must first be beaten with a lime whip (Siöbladh & Engeström 1750; Hidemark & Holmström 1984, p. 12pp).
