Trade and use of building lime

- early 19th-century lime barrels from an excavation in
Uddevalla, Bohuslän

Niklas Ytterberg & Kristin Balksten

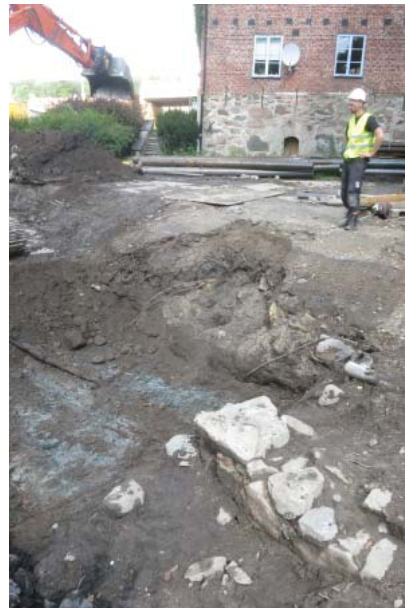
Figure 10. Parts of the wall in the 2014 trench with Hasselbackshuset in the background. The latter was built in 1814 and is one of the oldest standing houses in Uddevalla today. Mortar samples from the wall in the trench and the still standing house have been analysed in this study.

In an attempt to corroborate or refute such a hypothesis, additional chemical analyses were made of mortar from both the still standing Hasselbackshuset and the wall in the 2014 trench. The samples from the documented wall were both very similar, probably a sub-

hydraulic lime of the same kind as in the barrels. A sample from the mortar between the granite footings of Hasselbackshuset was quite similar to these both. Finally, the mortar from between the bricks in the same house was clearly different, a feebly hydraulic lime with a mixing ratio different from the others (Brorsson 2015). It can be concluded that the lime putties and mortars evidently belong to the same tradition.
