Dirt, dung and sanitation in the medieval Turku

- (Mis)Conceptions of medieval sanitation

Liisa Seppänen

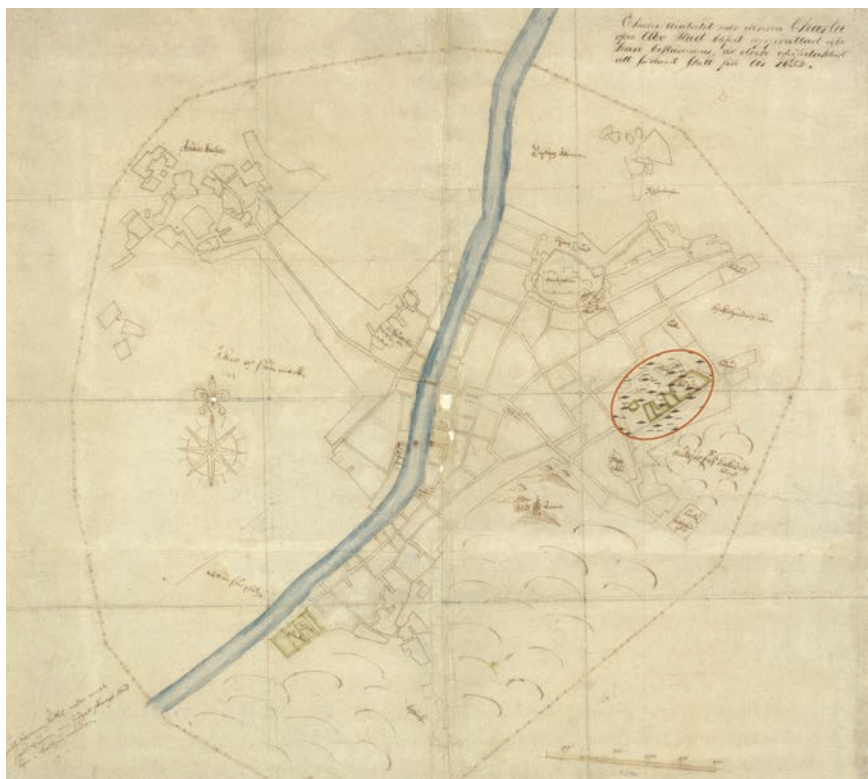
Figure 2. The location of Mätäjärvi has been marked with a circle and texture on the oldest map of Turku from the 1630s. On this map, there is no visible evidence of the lake and the only reference to the lake is the name of the hill (Mätäjärvi hill) on the south side of the marked area. The map does not provide any information about the medieval brooks either. Map: National archives of Finland (modifications made by the author).

there was a small lake (Mätäjärvi) in the northeastern part of the town, on the outskirts of Mätäjärvi quarter (Fig. 2). The lake is mentioned in medieval written sources only twice, in 1423 and in 1465, as a landmark defining plots, but otherwise there is no information of its size, use or condition (REA 407, 604). The lake was connected to the Aura River by two small brooks that ran through the central parts of the city. There are several mentions about the brooks in the medieval sources and in older archaeologi-

bably used as rubbish dump by the citizens of Turku (Salonen, Räsänen & Terho 1989, p. 172–173, see also Fig 2).

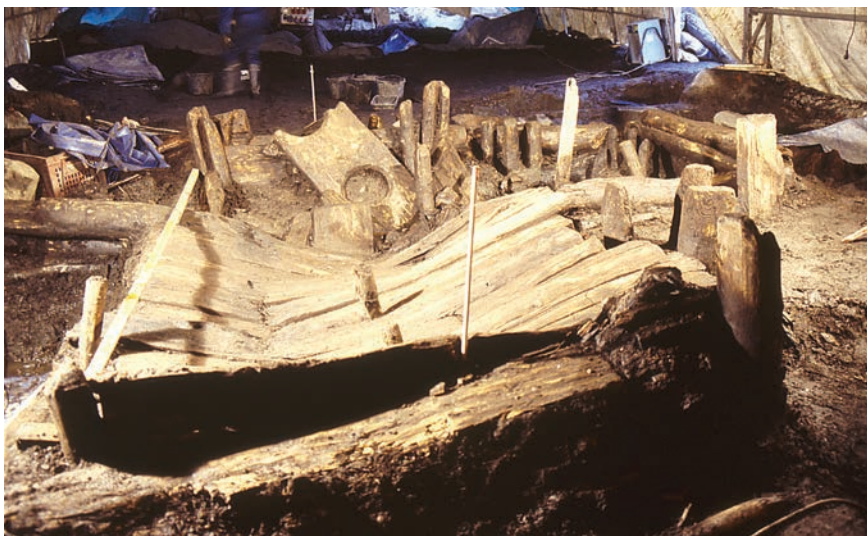
Figure 3. This timber framed privy found in Turku was built at the end of the 14th or early 15th century. The size of the privy was c. 5 m² and it contained a seat meant at least for two people. The privy was probably emptied prior to its abandonment at the end of the Middle Ages since the soil inside did not contain manure (Seppänen 2012b, p. 432, original photo: The Museum Centre of Turku).

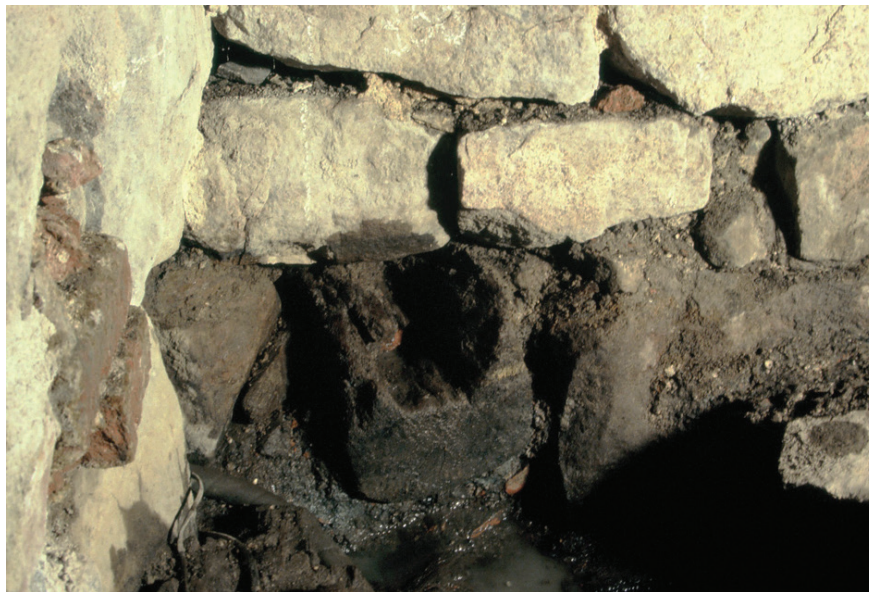
Figure 4. Wastewater management and placement of sewers was considered in the planning and construction of buildings, too. A masonry building from the 15th century was provided with a timber sewer leading the waters to the gutter of the adjacent street (Seppänen 2012b, p. 882, original photo: The Aboa Vetus & Ars Nova Museum, Turku).

In Turku, the sewers have been found in connection with the buildings (under and on the floors as well as underneath the walls), next to the buildings and plot borders as well as on the streets and yards (Fig. 4) The majority of the sewers were lined with planks or timber, but some sewers were lined with birch barks, branches, sticks, stones and even bricks. Some of the sewers were clearly related to handicrafts and activities, which needed lots of water like tanning, shoemaking and dying. Consequently, the sewers can be considered not only as the evidence of sanitation but also as an indicator of occupational distribution in the town area (Seppänen 2012b, p. 879–881).

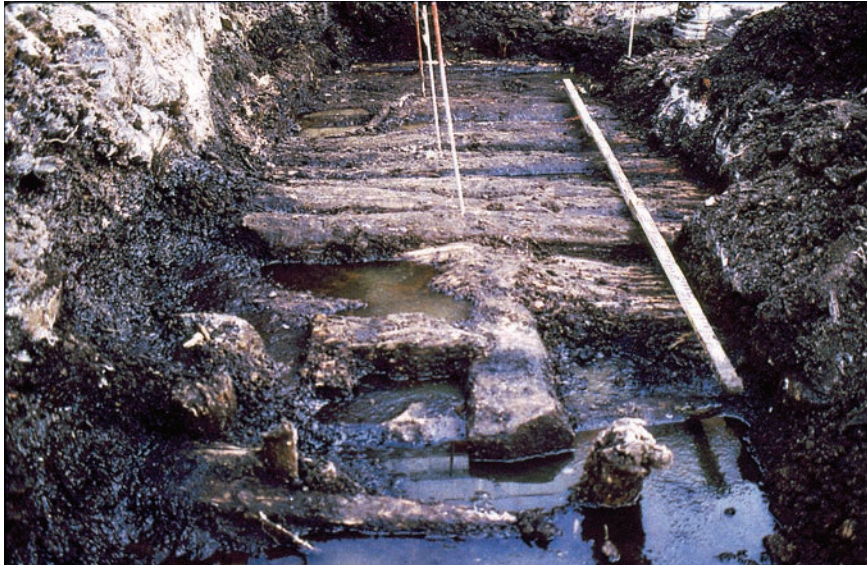
Figure 5. According to the present knowledge, the first streets with timber pavement were made in the 1370s in Mätäjärvi quarter (Seppänen 2012b, p. 461, original photo: The Museum Centre of Turku.).

The first streets with wooden pavements were made in Turku in the 1370s and 1380s when the town expanded into new areas (Fig. 5). Interestingly, it seems that in this phase, only the new streets were paved with timber while the older ones remained unpaved until the early 15th century. In the next phase, the streets were paved with stones. This seems to have taken place after a big fire in 1429 and when large parts of the town were reconstructed. Again, the oldest evidence of stone paved streets comes from the outskirts of the town and not in the centre. However, the lack of evidence can be explained by the possible reuse of stones when making a new surface. The removal of stones could only be detected when the surfaces are exposed with care and by documentation and analysis in detail. By the early 16th century, all streets in

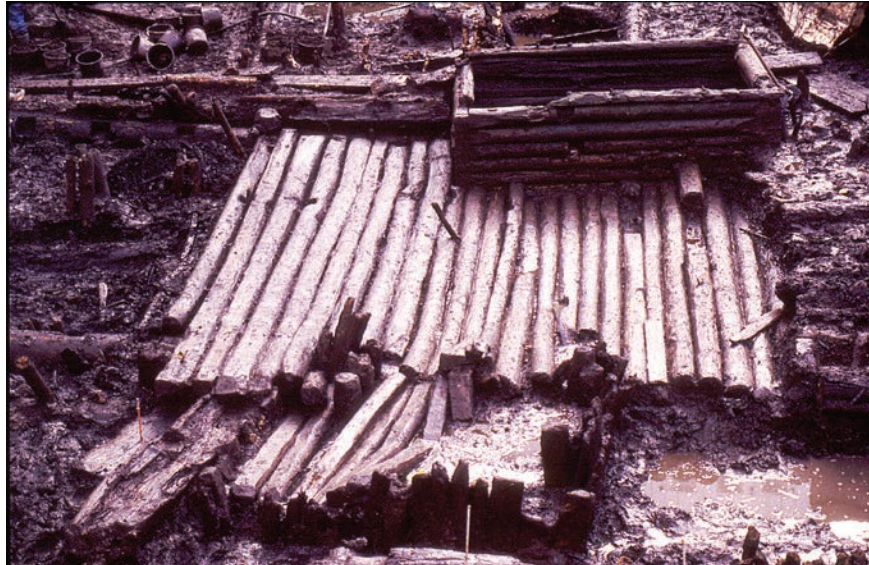
Figure 6. In Mätäjärvi quarter, a yard between two buildings was carefully paved with logs in the 1400s. The pavement covered an area of 43 m² (Seppänen 2012b, p. 359–365, original photo: The Museum Centre of Turku.).

of timber. This matches well with the time when the town started to flourish and develop in many different ways (Fig. 6).
