# Dirt, dung and sanitation in the medieval Turku

- (Mis)Conceptions of medieval sanitation

*Liisa Seppänen*

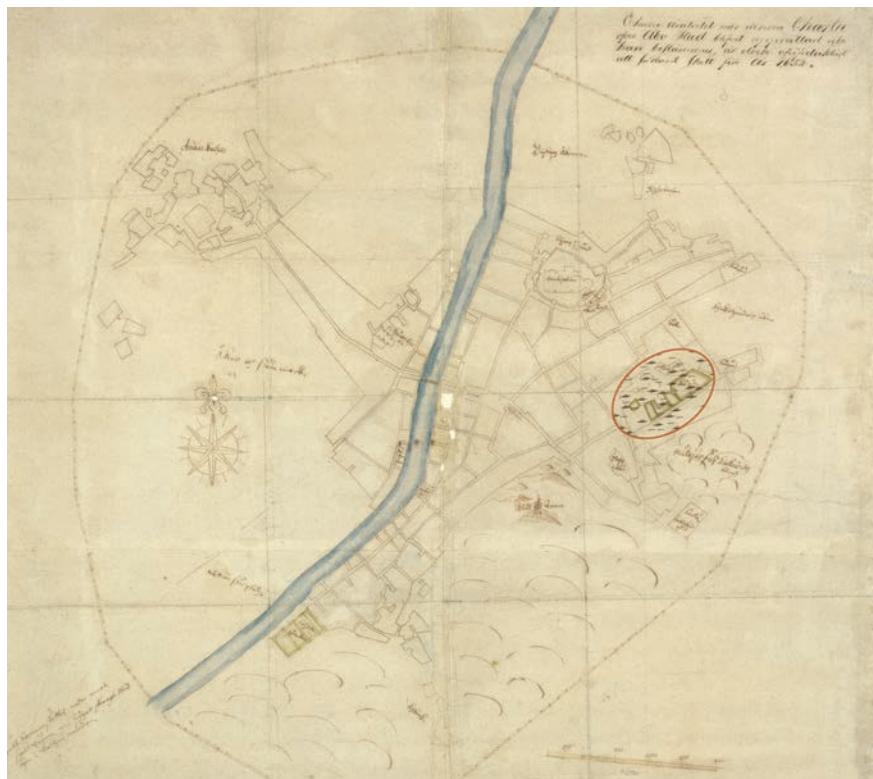
Figure 2. The location of Mätäjärvi has been marked with a circle and texture on the oldest map of Turku from the 1630s. On this map, there is no visible evidence of the lake and the only reference to the lake is the name of the hill (Mätäjärvi hill) on the south side of the marked area. The map does not provide any information about the medieval brooks either. Map: National archives of Finland (modifications made by the author).

there was a small lake (Mätäjärvi) in the northeastern part of the town, on the outskirts of Mätäjärvi quarter (Fig. 2). The lake is mentioned in medieval written sources only twice, in 1423 and in 1465, as a landmark defining plots, but otherwise there is no information of its size, use or condition (REA 407, 604). The lake was connected to the Aura River by two small brooks that ran through the central parts of the city. There are several mentions about the brooks in the medieval sources and in older archaeologi-

bably used as rubbish dump by the citizens of Turku (Salonen, Räsänen & Terho 1989, p. 172–173, see also Fig 2).

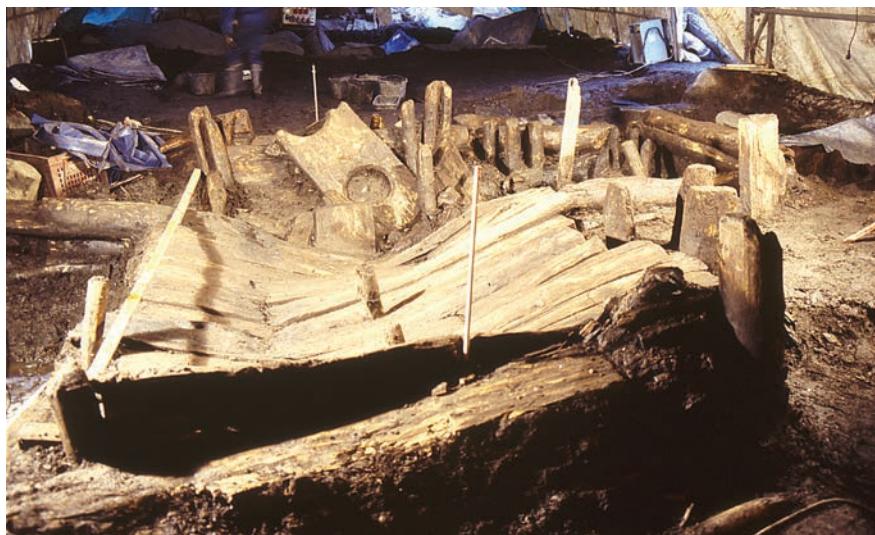
Figure 3. This timber framed privy found in Turku was built at the end of the 14th or early 15th century. The size of the privy was c. 5 m<sup>2</sup> and it contained a seat meant at least for two people. The privy was probably emptied prior to its abandonment at the end of the Middle Ages since the soil inside did not contain manure (Seppänen 2012b, p. 432, original photo: The Museum Centre of Turku).

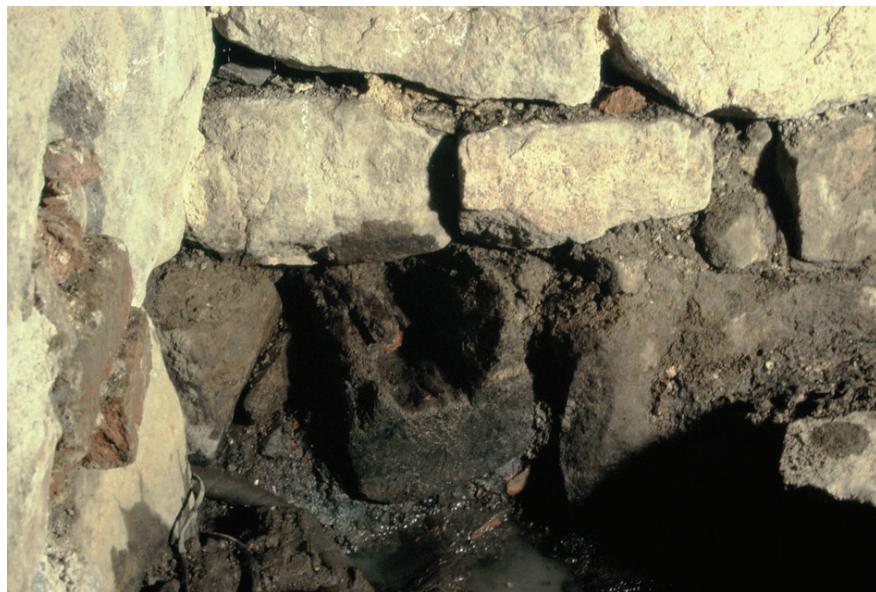
Figure 4. Wastewater management and placement of sewers was considered in the planning and construction of buildings, too. A masonry building from the 15th century was provided with a timber sewer leading the waters to the gutter of the adjacent street (Seppänen 2012b, p. 882, original photo: The Aboa Vetus & Ars Nova Museum, Turku).

In Turku, the sewers have been found in connection with the buildings (under and on the floors as well as underneath the walls), next to the buildings and plot borders as well as on the streets and yards (Fig. 4) The majority of the sewers were lined with planks or timber, but some sewers were lined with birch barks, branches, sticks, stones and even bricks. Some of the sewers were clearly related to handicrafts and activities, which needed lots of water like tanning, shoemaking and dying. Consequently, the sewers can be considered not only as the evidence of sanitation but also as an indicator of occupational distribution in the town area (Seppänen 2012b, p. 879–881).

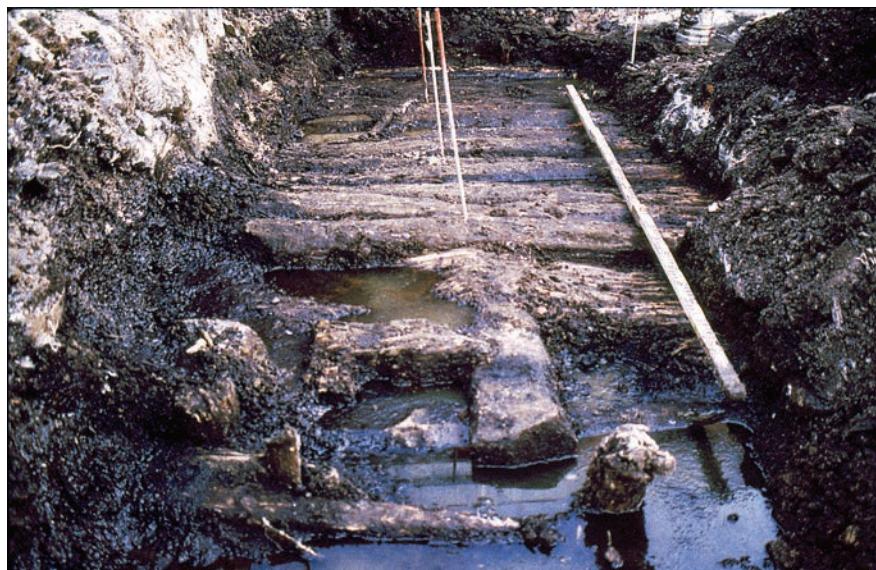
Figure 5. According to the present knowledge, the first streets with timber pavement were made in the 1370s in Mätäjärvi quarter (Seppänen 2012b, p. 461, original photo: The Museum Centre of Turku.).

The first streets with wooden pavements were made in Turku in the 1370s and 1380s when the town expanded into new areas (Fig. 5). Interestingly, it seems that in this phase, only the new streets were paved with timber while the older ones remained unpaved until the early 15th century. In the next phase, the streets were paved with stones. This seems to have taken place after a big fire in 1429 and when large parts of the town were reconstructed. Again, the oldest evidence of stone paved streets comes from the outskirts of the town and not in the centre. However, the lack of evidence can be explained by the possible reuse of stones when making a new surface. The removal of stones could only be detected when the surfaces are exposed with care and by documentation and analysis in detail. By the early 16th century, all streets in

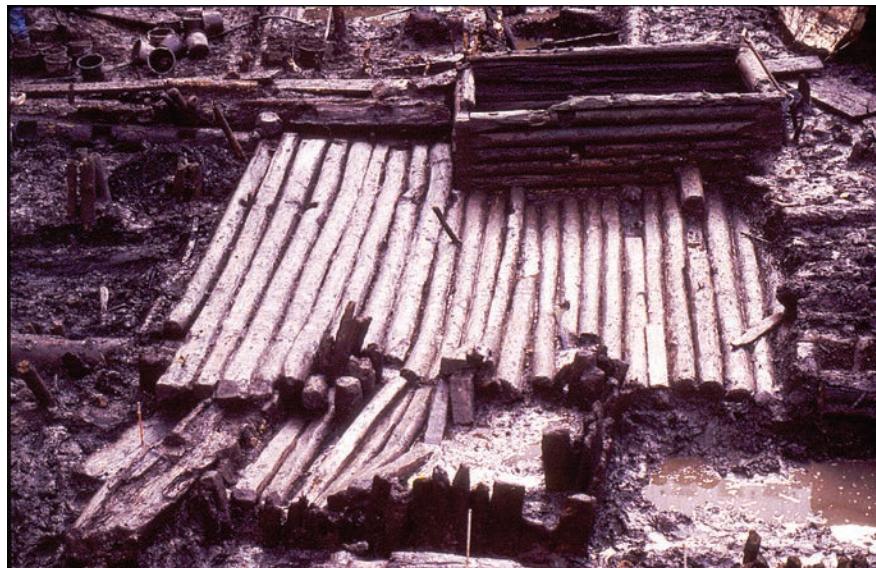
Figure 6. In Mätäjärvi quarter, a yard between two buildings was carefully paved with logs in the 1400s. The pavement covered an area of 43 m<sup>2</sup> (Seppänen 2012b, p. 359–365, original photo: The Museum Centre of Turku.).

of timber. This matches well with the time when the town started to flourish and develop in many different ways (Fig. 6).

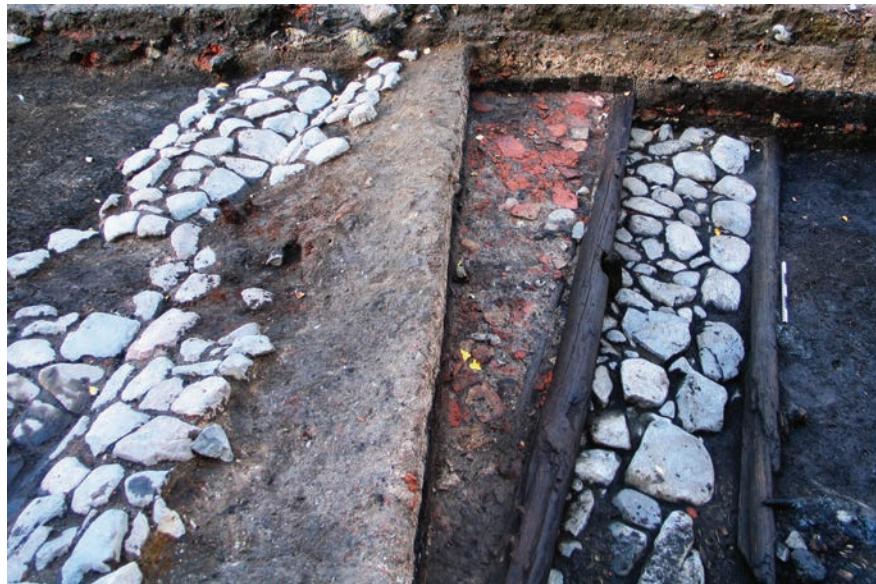
Fig. 7. The photo presents the stratigraphy of different pavements and phases of the School Square. In the oldest phase (on right), the square was provided with a stone paved lane framed with logs. In the next phase (middle), the lane was paved with bricks while the square remained unpaved. The square was paved with stones in the late 15th century or in the early 16th century (left). Photo: Päivi Repo.
