Naust

– the boathouses of Nyköping and the echoes of power

Tomas Westberg

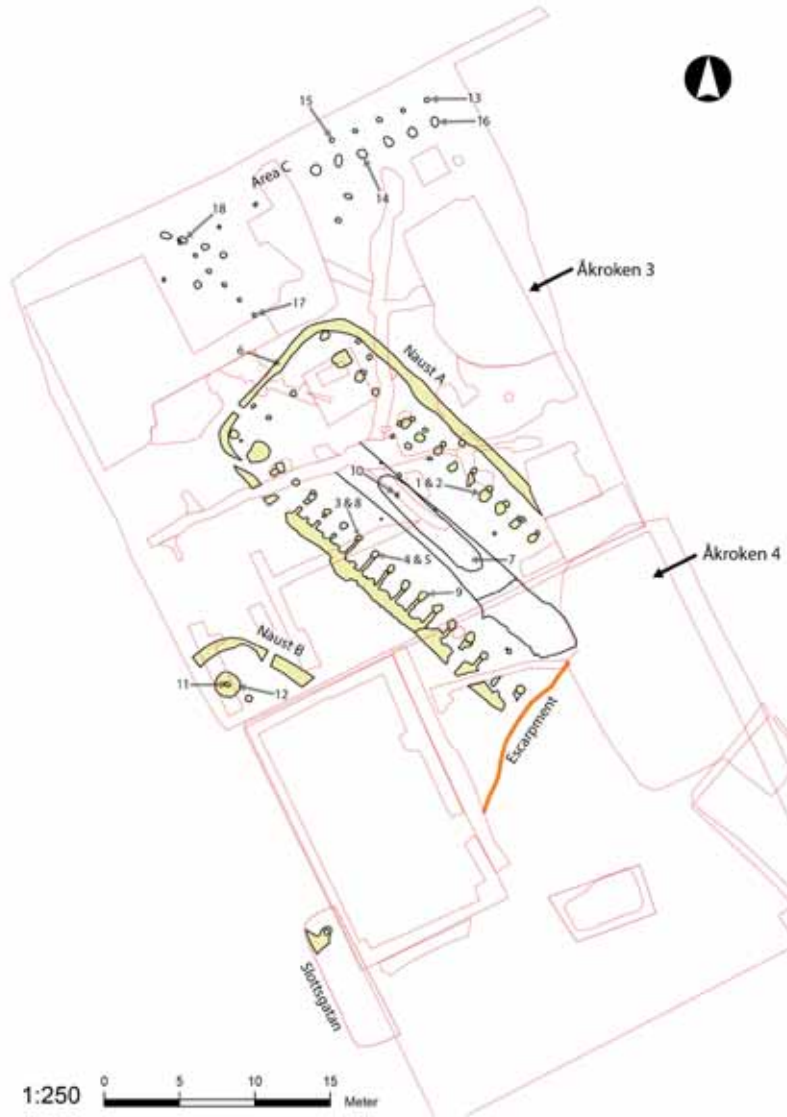
Fig. 1. Overview. Opaque lines represent excavation areas, disturbances, test trenches and modern buildings. The numbers display features sampled for radiocarbon dating (cf. tab. 1). Graufelds & Westberg 2013.

An additional area with clusters of postholes (henceforth Area C, fig. 1), contemporary with naust A, was encountered in the north and northeast corner of Åkroken 3 and is consequently included in the discussion.

Additional solitary postholes were encountered just inside the corners of the enclosing trench in the northwest in naust A on each side (fig. 1, 2). These have been interpreted as constituting additional support for the gable but can also have functioned as anchoring for a construction of some sort of larger doors or gateway (cf. fig. 3, 4). No postholes or other features that could constitute wall constructions for solid or closed short sides were found, which proves that they were free from grounded constructions. However, with regards to the fact that the drainage trench was intact in this section of both buildings, some sort of overhang probably ex-

Table 1. Radiocarbon dating. Cf. fig 1 for sampled features.

The second unit, consisting of five somewhat larger postholes, ran in a direction from west-northwest to east-southeast and had the shape of a backward L (fig. 1). The functions of these constructions are somewhat unclear. It is however apparent that it is not a question of buildings per se (except perhaps the first one). They are merely included in this discussion since they are contempora-

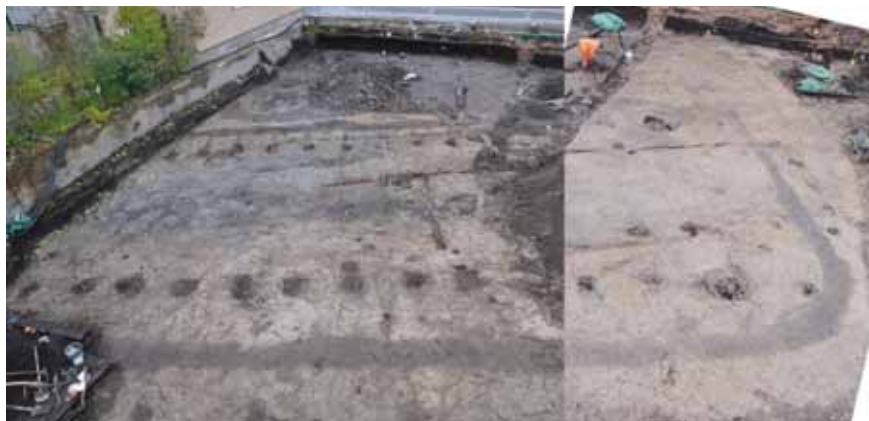
Figure 2. Merged photographs of naust A. The building was excavated in two sections in Åkroken 3 due to dump-management. The southeastern part of the building was situated underneath the wall to the left in the picture within Åkroken 4. Photo from the northeast. 2010 RAÄ Uv Mitt.

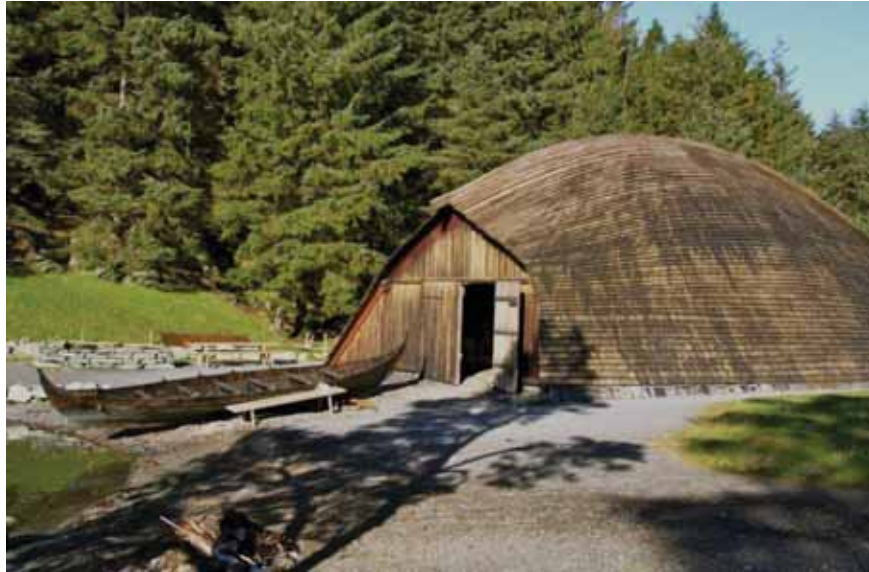
Figure 4. Reconstructed naust at Avaldsnes, Nordvegen Historiesenter. Used with permission.

As mentioned above, it is unlikely that the structures did not have closed surrounding walls (excepting the side facing the water). One possibility is that the roof was conjoined with the wall construction, following the angle and fastened to the supposed buttress-like/support post construction down towards the ground, albeit placing the drainage-trench on the outer side of the buildings (possibly similar to the reconstructed naust at Avaldsnes, fig. 4).
