Naust

– the boathouses of Nyköping and the echoes of power

Tomas Westberg

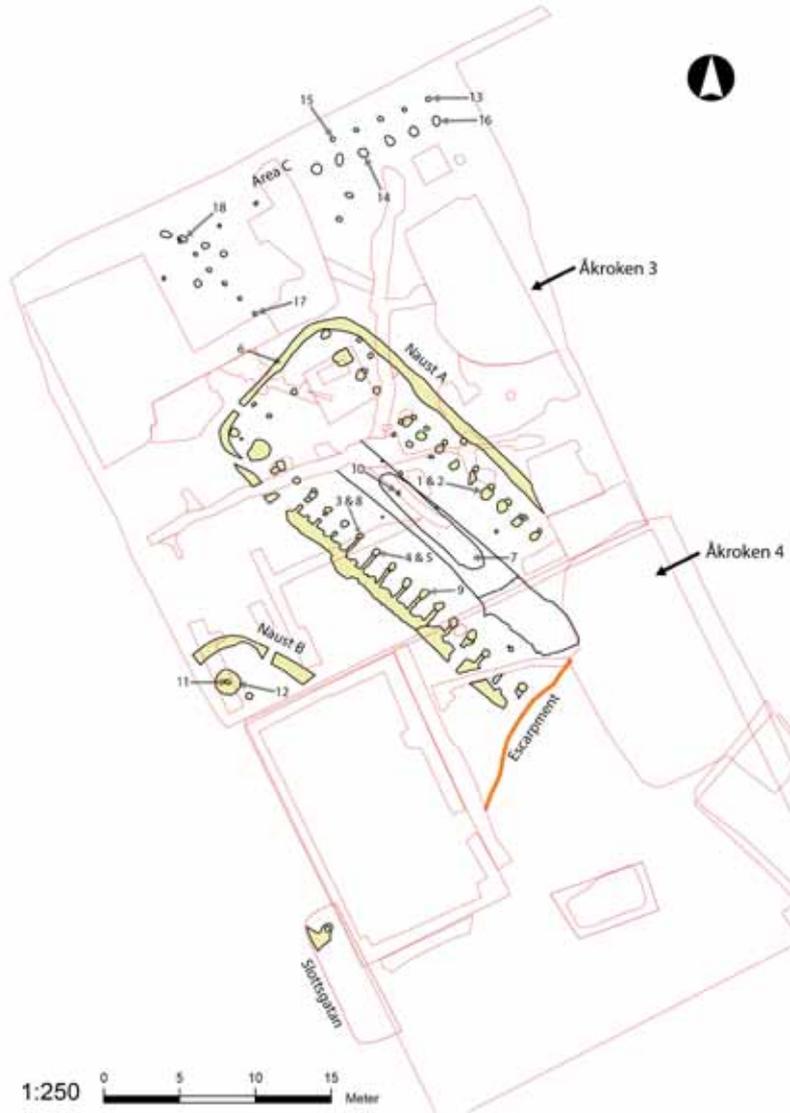
Fig. 1. Overview. Opaque lines represent excavation areas, disturbances, test trenches and modern buildings. The numbers display features sampled for radiocarbon dating (cf. tab. 1). Graufelds & Westberg 2013.

An additional area with clusters of postholes (henceforth Area C, fig. 1), contemporary with naust A, was encountered in the north and northeast corner of Åkroken 3 and is consequently included in the discussion.

Additional solitary postholes were encountered just inside the corners of the enclosing trench in the northwest in naust A on each side (fig. 1, 2). These have been interpreted as constituting additional support for the gable but can also have functioned as anchoring for a construction of some sort of larger doors or gateway (cf. fig. 3, 4). No postholes or other features that could constitute wall constructions for solid or closed short sides were found, which proves that they were free from grounded constructions. However, with regards to the fact that the drainage trench was intact in this section of both buildings, some sort of overhang probably ex-

The second unit, consisting of five somewhat larger postholes, ran in a direction from west-northwest to east-southeast and had the shape of a backward L (fig. 1). The functions of these constructions are somewhat unclear. It is however apparent that it is not a question of buildings per se (except perhaps the first one). They are merely included in this discussion since they are contempora-

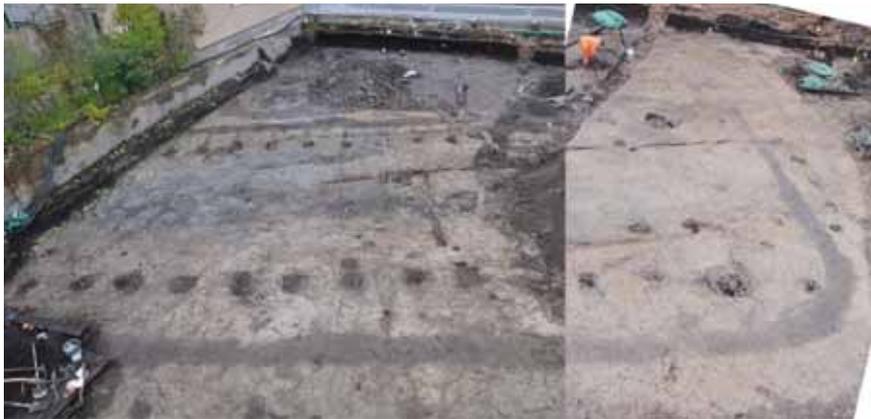
Figure 2. Merged photographs of naust A. The building was excavated in two sections in Åkroken 3 due to dump-management. The southeastern part of the building was situated underneath the wall to the left in the picture within Åkroken 4. Photo from the northeast. 2010 RAÄ Uv Mitt.
