Trade and use of building lime

- early 19th-century lime barrels from an excavation in
Uddevalla, Bohuslän

Niklas Ytterberg & Kristin Balksten

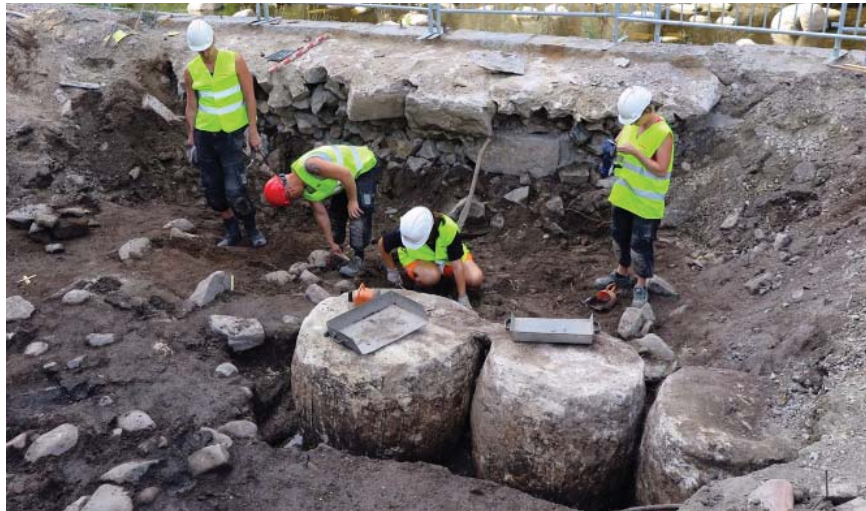
Figure 3a. Photo of the lime barrels (from the left) 4, 3 and 2, which were excavated during the summer of 2014. They have differing sizes but seem to hold similar lime putties. Photo: Kristin Balksten.

The four large barrels full of lime putty were placed in a large pit, 4.7 by 1.6 metres wide and approximately 1 metre deep. The fill consisted of redeposited 17th and 18th century material from truncated earlier deposits, the most recent finds dating to c. 1770. On top of the barrels there were traces of a cover, consisting of at least ten slats of small dimensions, along with some nails. Directly on top of the cover we found significant amounts of

In order to gain a better understanding of how the lime putty was prepared and treated, a more detailed description of the barrels is required. The biggest barrel, to the north-west, measured 1.15 m in maximum width, and the second biggest, at the end of the row to the south-east, measured around 1 m. The two barrels in the middle were slightly smaller, c. 0.8 m. The height differed from c. 0.8 to 1 m, making the barrels a bit wider than they were high. The barrels were bulged slightly in the middle, as usual. The staves were very poorly preserved. Impressions of the staves in the lime putty revealed an individual width of 0.10 - 0.15 m (4 to 6 inches) and a thickness of about 25 mm (1 inch). Preserved fragments of hoops indicate that they appear to be made of birch, whereas the bases of the barrels are made of pine. No head or lids are preserved, but these may very well never have been present. Three of the barrels contained a more greyish, lumpy lime and one barrel a distinctly white, creamy lime. We saw quite a lot of lime lumps in the pit, especially in the top fill close to the barrels' mouths. A probable explanation for this is that quicklime spilled over in the process of tipping it from smaller barrels to these ground-fixed barrels.

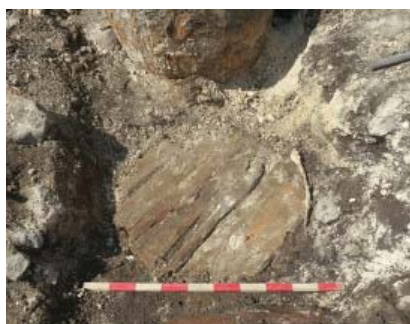
Figure 3c. Photo of the base of barrel 4, made of pine. Photo: Veronica Forsblom Ljungdahl.
