# Trade and use of building lime

- early 19<sup>th</sup>-century lime barrels from an excavation in  
Uddevalla, Bohuslän

*Niklas Ytterberg & Kristin Balksten*

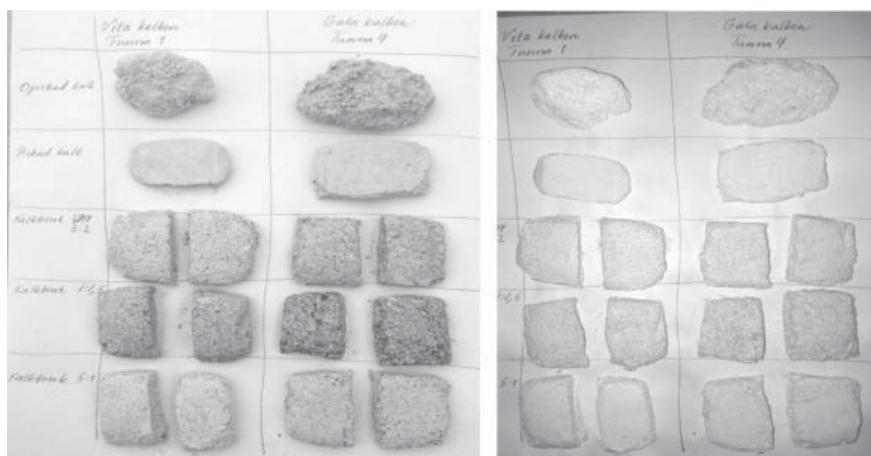
Figure 5. The experimental samples when they are fresh (to the left) and after two weeks (to the right), when they have been dried white. The samples that seemed very lean as fresh appeared more lime rich after hardening. Photo: Kristin Balksten.

Both kinds of lime in the Uddevalla find were grainy and stiff when found, but it was possible to whip them. As the lime was experimentally whipped it also became more runny, suggesting to us that it might still be possible to use it. In order to try out its properties as a binder, mortar samples were taken from each type, see table 1. A direct comparison can be made between our samples and earth slaked and wet slaked Gotlandic lime, which are described more completely in Traditional lime mortar and plaster (Balksten 2007).
