Dirt, dung and sanitation in the medieval Turku

- (Mis)Conceptions of medieval sanitation

Liisa Seppänen

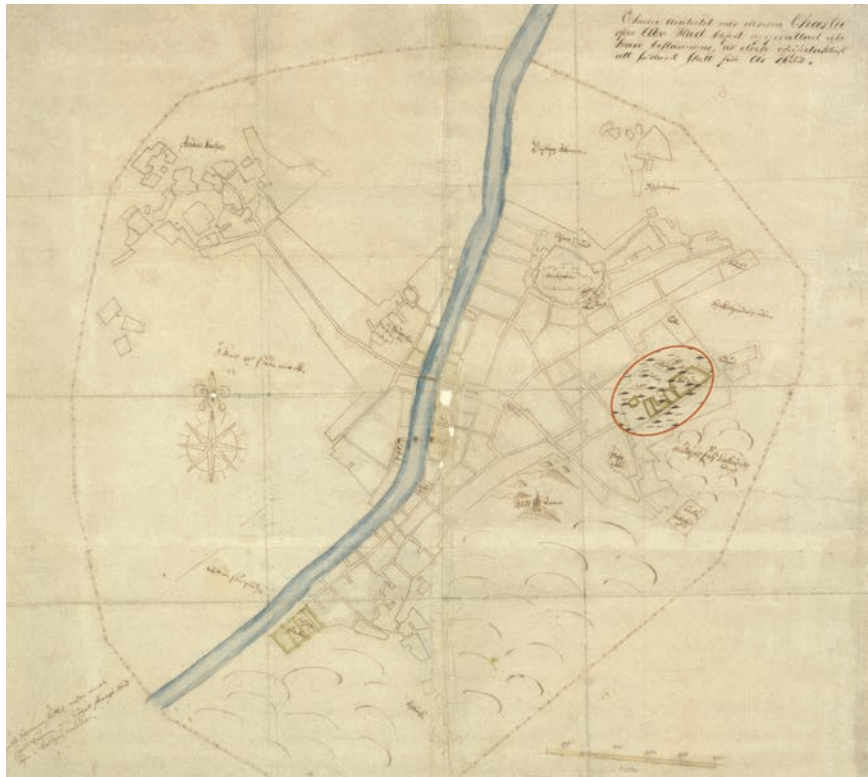
Figure 2. The location of Mätäjärvi has been marked with a circle and texture on the oldest map of Turku from the 1630s. On this map, there is no visible evidence of the lake and the only reference to the lake is the name of the hill (Mätäjärvi hill) on the south side of the marked area. The map does not provide any information about the medieval brooks either. Map: National archives of Finland (modifications made by the author).

there was a small lake (Mätäjärvi) in the northeastern part of the town, on the outskirts of Mätäjärvi quarter (Fig. 2). The lake is mentioned in medieval written sources only twice, in 1423 and in 1465, as a landmark defining plots, but otherwise there is no information of its size, use or condition (REA 407, 604). The lake was connected to the Aura River by two small brooks that ran through the central parts of the city. There are several mentions about the brooks in the medieval sources and in older archaeologi-

bably used as rubbish dump by the citizens of Turku (Salonen, Räsänen & Terho 1989, p. 172–173, see also Fig 2).

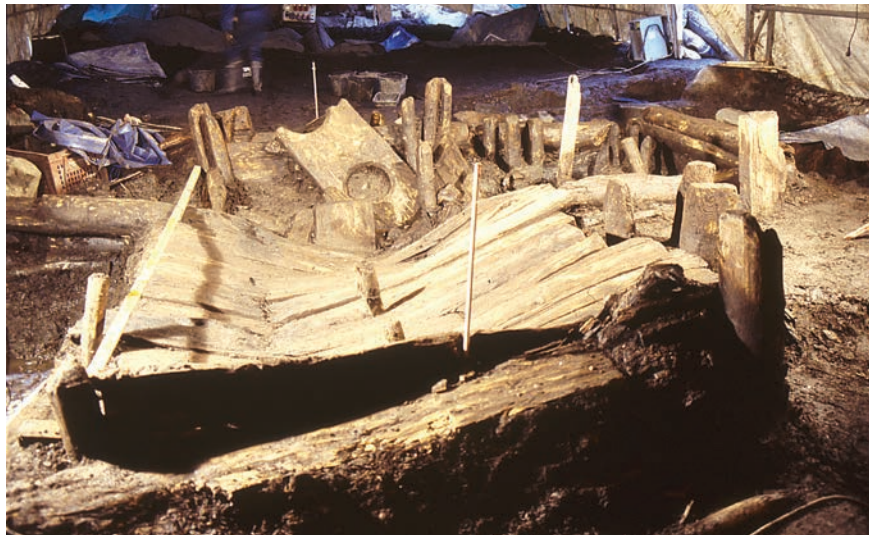
Figure 3. This timber framed privy found in Turku was built at the end of the 14th or early 15th century. The size of the privy was c. 5 m² and it contained a seat meant at least for two people. The privy was probably emptied prior to its abandonment at the end of the Middle Ages since the soil inside did not contain manure (Seppänen 2012b, p. 432, original photo: The Museum Centre of Turku).

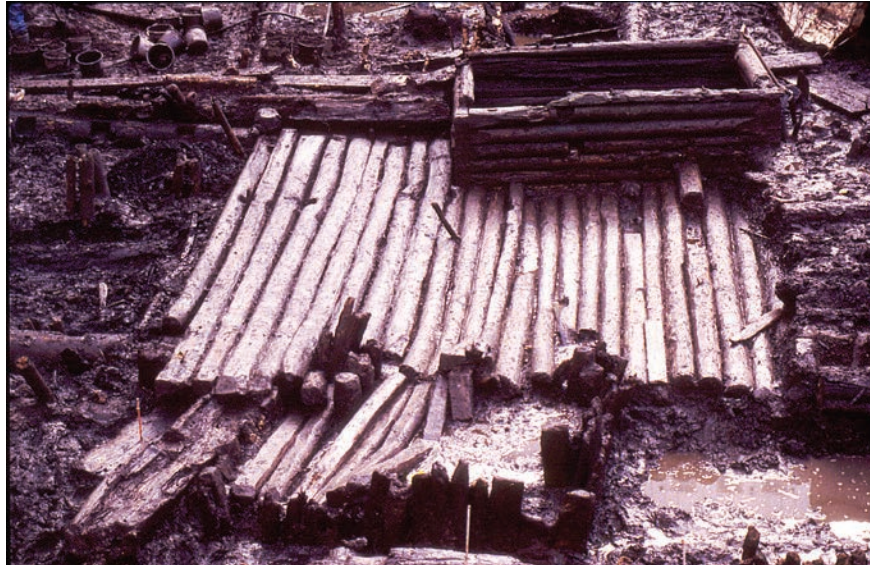
Figure 6. In Mätäjärvi quarter, a yard between two buildings was carefully paved with logs in the 1400s. The pavement covered an area of 43 m² (Seppänen 2012b, p. 359–365, original photo: The Museum Centre of Turku.).

of timber. This matches well with the time when the town started to flourish and develop in many different ways (Fig. 6).

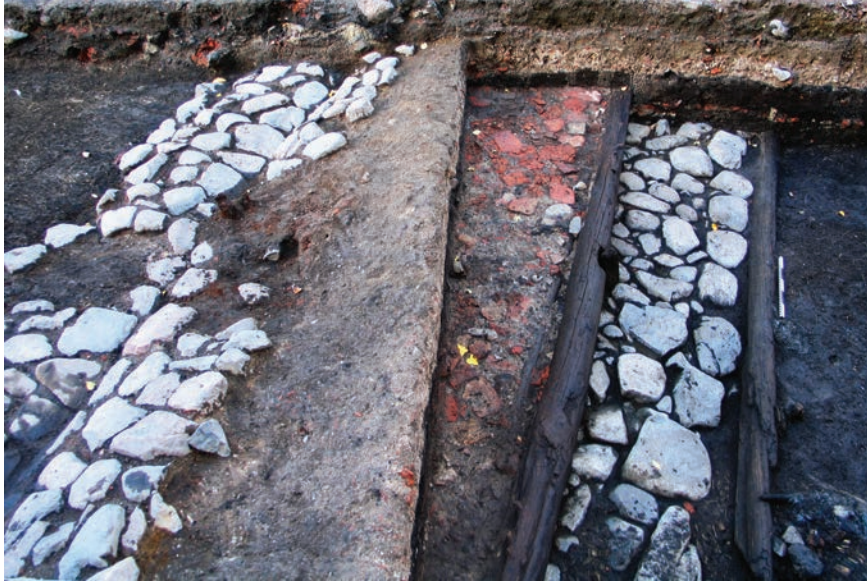
Fig. 7. The photo presents the stratigraphy of different pavements and phases of the School Square. In the oldest phase (on right), the square was provided with a stone paved lane framed with logs. In the next phase (middle), the lane was paved with bricks while the square remained unpaved. The square was paved with stones in the late 15th century or in the early 16th century (left). Photo: Päivi Repo.
