# Dirt, dung and sanitation in the medieval Turku

- (Mis)Conceptions of medieval sanitation

*Liisa Seppänen*

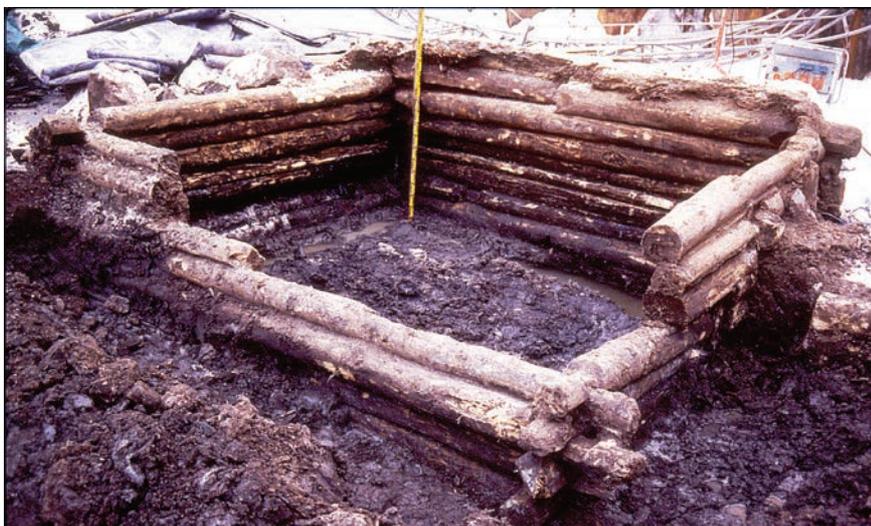
Figure 1. This construction was used as a latrine at the end of the 14th century before it became a foundation for a privy built partly on top of it (see Fig.3). The missing logs in front of the frame indicate the place of the younger privy (Seppänen 2012b, p. 476, original photo: The Museum Centre of Turku.).

There were many different kinds of latrines: A latrine could have been a simple pit, which may have been lined with timber, stones or bricks. Quite often, privies, old abandoned wells, barrels and also foundations of ruined buildings have been used as latrines, too (Fig. 1). Therefore, latrines cannot be defined by their

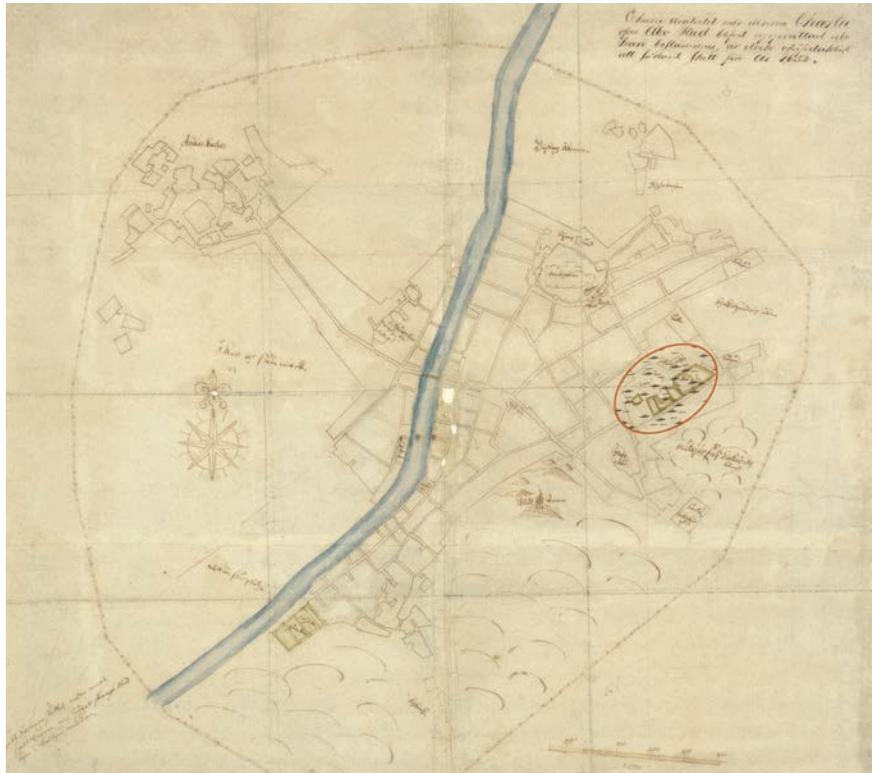
Figure 2. The location of Mätäjärvi has been marked with a circle and texture on the oldest map of Turku from the 1630s. On this map, there is no visible evidence of the lake and the only reference to the lake is the name of the hill (Mätäjärvi hill) on the south side of the marked area. The map does not provide any information about the medieval brooks either. Map: National archives of Finland (modifications made by the author).

there was a small lake (Mätäjärvi) in the northeastern part of the town, on the outskirts of Mätäjärvi quarter (Fig. 2). The lake is mentioned in medieval written sources only twice, in 1423 and in 1465, as a landmark defining plots, but otherwise there is no information of its size, use or condition (REA 407, 604). The lake was connected to the Aura River by two small brooks that ran through the central parts of the city. There are several mentions about the brooks in the medieval sources and in older archaeologi-

bably used as rubbish dump by the citizens of Turku (Salonen, Räsänen & Terho 1989, p. 172–173, see also Fig 2).

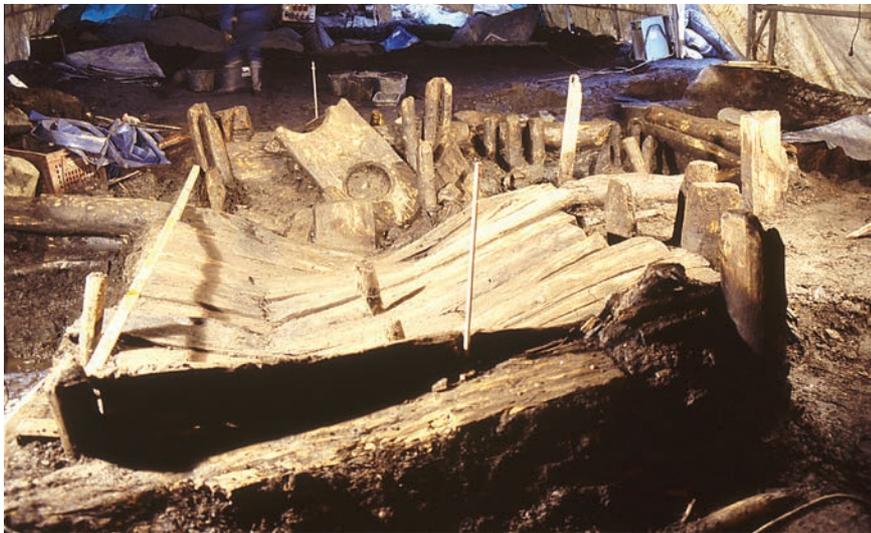
*Figure 3. This timber framed privy found in Turku was built at the end of the 14th or early 15th century. The size of the privy was c. 5 m<sup>2</sup> and it contained a seat meant at least for two people. The privy was probably emptied prior to its abandonment at the end of the Middle Ages since the soil inside did not contain manure (Seppänen 2012b, p. 432, original photo: The Museum Centre of Turku).*

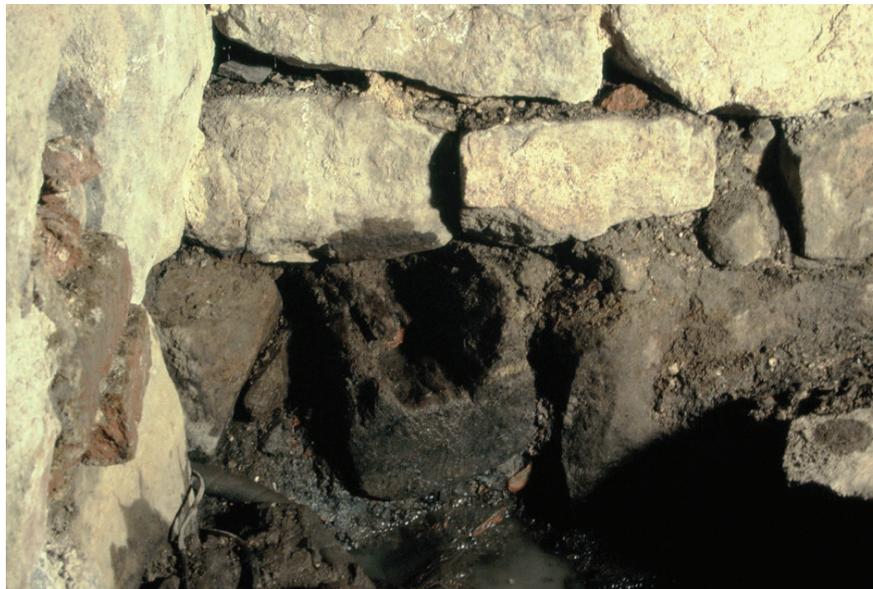
Figure 4. Wastewater management and placement of sewers was considered in the planning and construction of buildings, too. A masonry building from the 15th century was provided with a timber sewer leading the waters to the gutter of the adjacent street (Seppänen 2012b, p. 882, original photo: The Aboa Vetus & Ars Nova Museum, Turku).

In Turku, the sewers have been found in connection with the buildings (under and on the floors as well as underneath the walls), next to the buildings and plot borders as well as on the streets and yards (Fig. 4) The majority of the sewers were lined with planks or timber, but some sewers were lined with birch barks, branches, sticks, stones and even bricks. Some of the sewers were clearly related to handicrafts and activities, which needed lots of water like tanning, shoemaking and dying. Consequently, the sewers can be considered not only as the evidence of sanitation but also as an indicator of occupational distribution in the town area (Seppänen 2012b, p. 879–881).

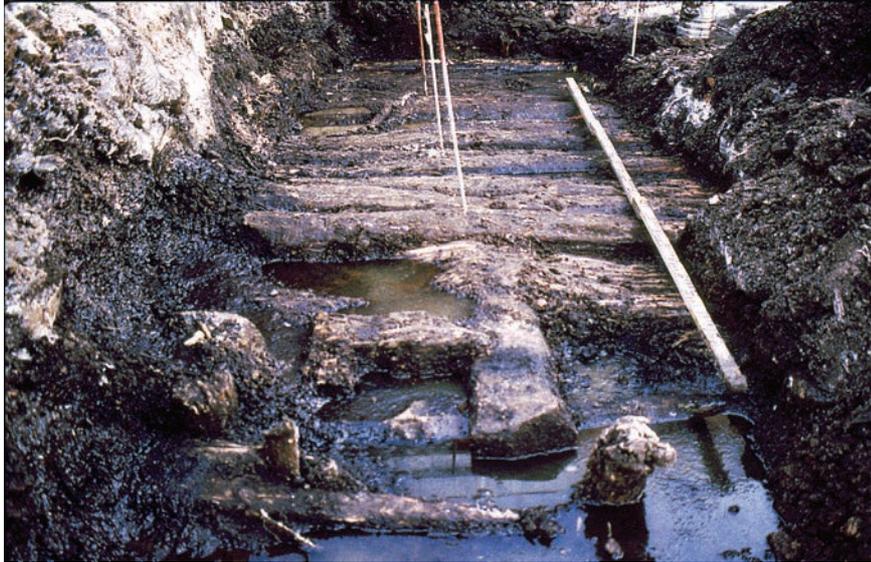
Figure 5. According to the present knowledge, the first streets with timber pavement were made in the 1370s in Mätäjärvi quarter (Seppänen 2012b, p. 461, original photo: The Museum Centre of Turku.).

The first streets with wooden pavements were made in Turku in the 1370s and 1380s when the town expanded into new areas (Fig. 5). Interestingly, it seems that in this phase, only the new streets were paved with timber while the older ones remained unpaved until the early 15th century. In the next phase, the streets were paved with stones. This seems to have taken place after a big fire in 1429 and when large parts of the town were reconstructed. Again, the oldest evidence of stone paved streets comes from the outskirts of the town and not in the centre. However, the lack of evidence can be explained by the possible reuse of stones when making a new surface. The removal of stones could only be detected when the surfaces are exposed with care and by documentation and analysis in detail. By the early 16th century, all streets in

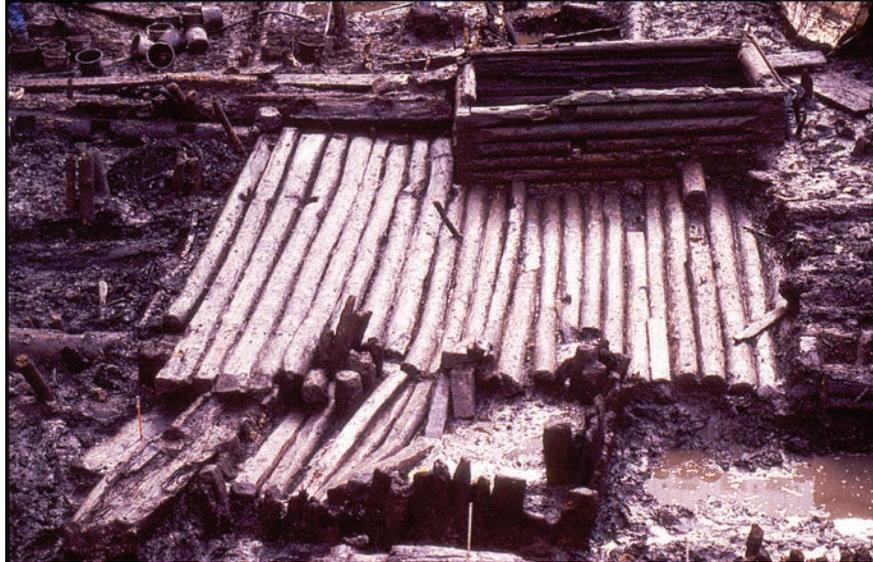
Figure 6. In Mätäjärvi quarter, a yard between two buildings was carefully paved with logs in the 1400s. The pavement covered an area of 43 m<sup>2</sup> (Seppänen 2012b, p. 359–365, original photo: The Museum Centre of Turku.).

of timber. This matches well with the time when the town started to flourish and develop in many different ways (Fig. 6).

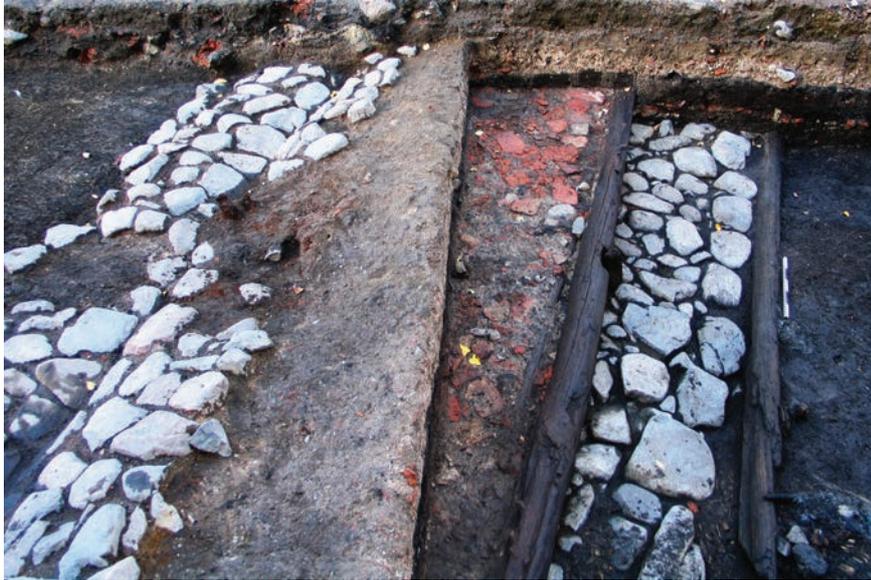
*Fig. 7. The photo presents the stratigraphy of different pavements and phases of the School Square. In the oldest phase (on right), the square was provided with a stone paved lane framed with logs. In the next phase (middle), the lane was paved with bricks while the square remained unpaved. The square was paved with stones in the late 15th century or in the early 16th century (left). Photo: Päivi Repo.*
