Dirt, dung and sanitation in the medieval Turku

- (Mis)Conceptions of medieval sanitation

Liisa Seppänen

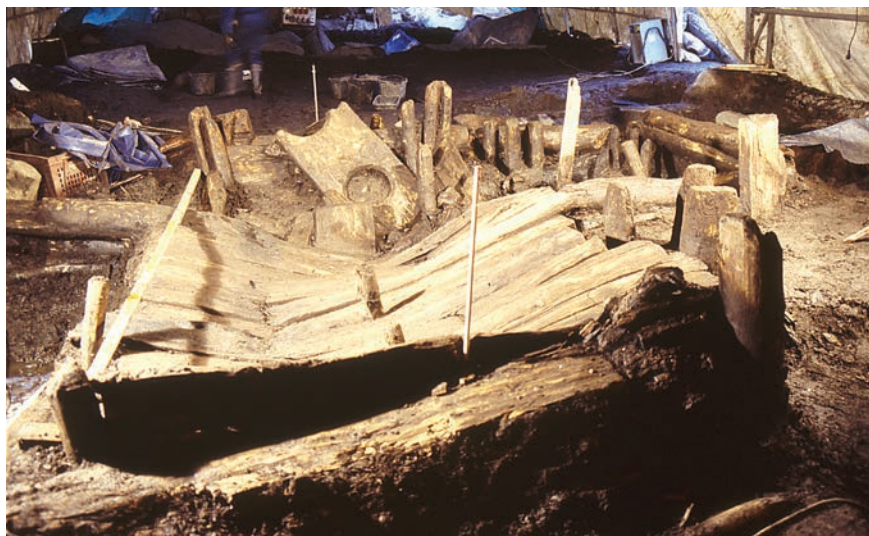
Figure 3. This timber framed privy found in Turku was built at the end of the 14th or early 15th century. The size of the privy was c. 5 m² and it contained a seat meant at least for two people. The privy was probably emptied prior to its abandonment at the end of the Middle Ages since the soil inside did not contain manure (Seppänen 2012b, p. 432, original photo: The Museum Centre of Turku).

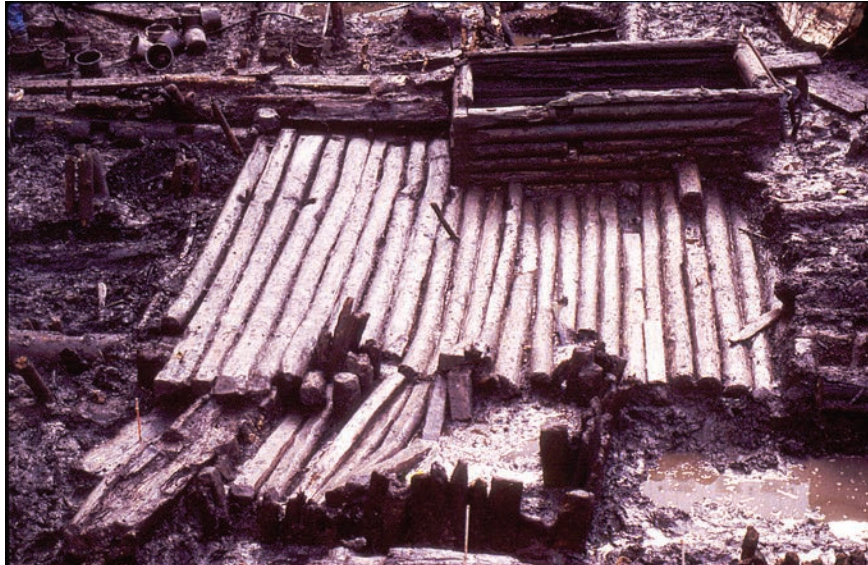
Figure 6. In Mätäjärvi quarter, a yard between two buildings was carefully paved with logs in the 1400s. The pavement covered an area of 43 m² (Seppänen 2012b, p. 359–365, original photo: The Museum Centre of Turku.).

It seems that as soon as Turku was inhabited some of the passages and yards were covered with planks and timber to facilitate walking and transportation. The more systematic paving of yards took place at the end of the 14th century following the paving of the streets (Seppänen 2012b, p. 882–883). In Novgorod, which is famous for its well-preserved yard pavements, the first pavements were made more carefully and with more laborious techniques (Khoroshev & Sorokin 1992, p. 55). In Turku we have not been able to make this kind of conclusion. In the early 15th century, however, the wooden pavements were made with utmost care and with a good quality

of timber. This matches well with the time when the town started to flourish and develop in many different ways (Fig. 6).
