Dirt, dung and sanitation in the medieval Turku

- (Mis)Conceptions of medieval sanitation

Liisa Seppänen

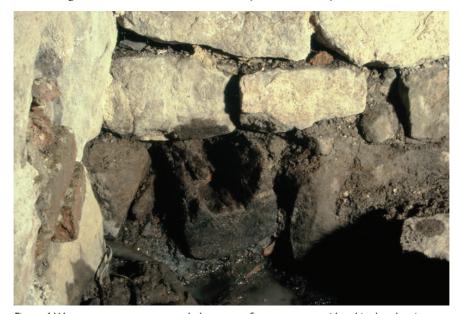
Figure 4. Wastewater management and placement of sewers was considered in the planning and construction of buildings, too. A masonry building from the 15th century was provided with a timber sewer leading the waters to the gutter of the adjacent street (Seppänen 2012b, p. 882, original photo:The Aboa Vetus & Ars Nova Museum, Turku).

In Turku, the sewers have been found in connection with the buildings (under and on the floors as well as underneath the walls), next to the buildings and plot borders as well as on the streets and yards (Fig. 4) The majority of the sewers were lined with planks or timber, but some sewers were lined with birch barks, branches, sticks, stones and even bricks. Some of the sewers were clearly related to handicrafts and activities, which needed lots of water like tanning, shoemaking and dying. Consequently, the sewers can be considered not only as the evidence of sanitation but also as an indicator of occupational distribution in the town area (Seppänen 2012b, p. 879-881).

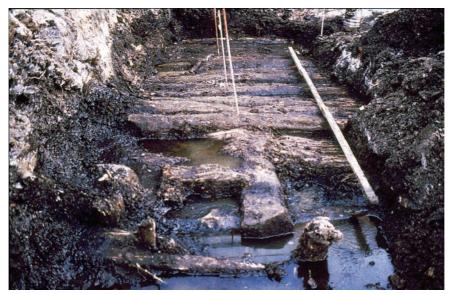
Figure 5. According to the present knowledge, the first streets with timber pavement were made in the 1370s in Mätäjärvi quarter (Seppänen 2012b, p. 461, original photo: The Museum Centre of Turku.).

The first streets with wooden pavements were made in Turku in the 1370s and 1380s when the town expanded into new areas (Fig. 5). Interestingly, it seems that in this phase, only the new streets were paved with timber while the older ones remained unpaved until the early 15th century. In the next phase, the streets were paved with stones. This seems to have taken place after a big fire in 1429 and when large parts of the town were reconstructed. Again, the oldest evidence of stone paved streets comes from the outskirts of the town and not in the centre. However, the lack of evidence can be explained by the possible reuse of stones when making a new surface. The removal of stones could only be detected when the surfaces are exposed with care and by documentation and analysis in detail. By the early 16th century, all streets in

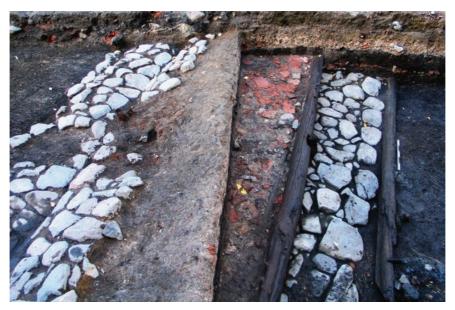
Fig. 7.The photo presents the stratigraphy of different pavements and phases of the School Square. In the oldest phase (on right), the square was provided with a stone paved lane framed with logs. In the next phase (middle), the lane was paved with bricks while the square remained unpaved. The square was paved with stones in the late 15th century or in the early 16th century (left). Photo: Päivi Repo.
